MEMBRANE WATERPROOFING APPLICATIONS IN NEW YORK SECOND INTERIM REPORT

TECHNICAL REPORT 34 JUNE, 1978

2nd Interim Report

June, 1978 (Technical Report 34)

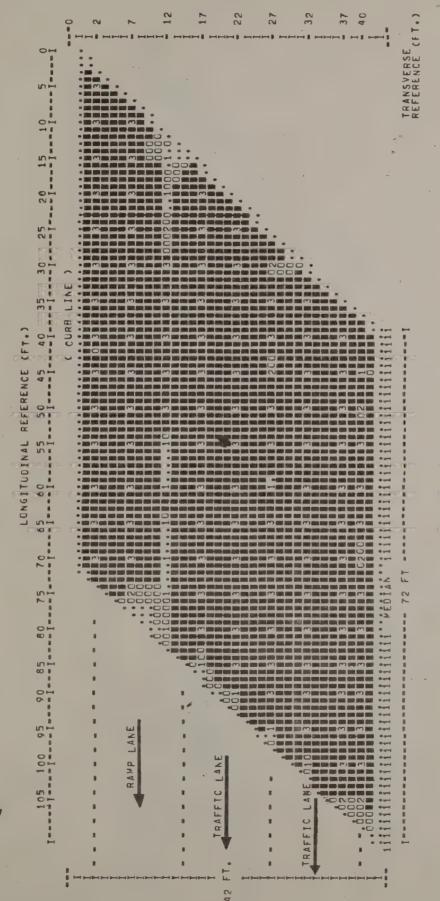
1977 Survey (In-Service - 1 year) Figure 1 - Electrical Resistance

Figures 1 thru 4 are the contour plots of the electrical resistance and corrosion potential surveys. From Figures 1 and 3, it can be seen that the majority of deck areas showed an electrical resistance value in excess of 500 kil-ohm-s.f. In Figures 2 and 4, the corrosion potentials are plotted. Span 1, shows that the greatest number of data points were recorded as less than 0.20v. (70 measurements); however, 44 values were measured in the undefined performance interval (0.20 to 0.35v.) and 9 data points exceeded 0.35v. On Span 2 (Figure 4), the corrosion potentials are seen to be more uniform; 156 measurements are less than 0.20v., 32 are between 0.2-0.35v., and 10 values exceeded 0.35v.
